One Time Request-
WUDU Station and Fire Egress
Design Plan

A.D. BRUCE RELIGION CENTER

WUDU Station and Fire Egress Design Plan – AD Bruce Religion Center

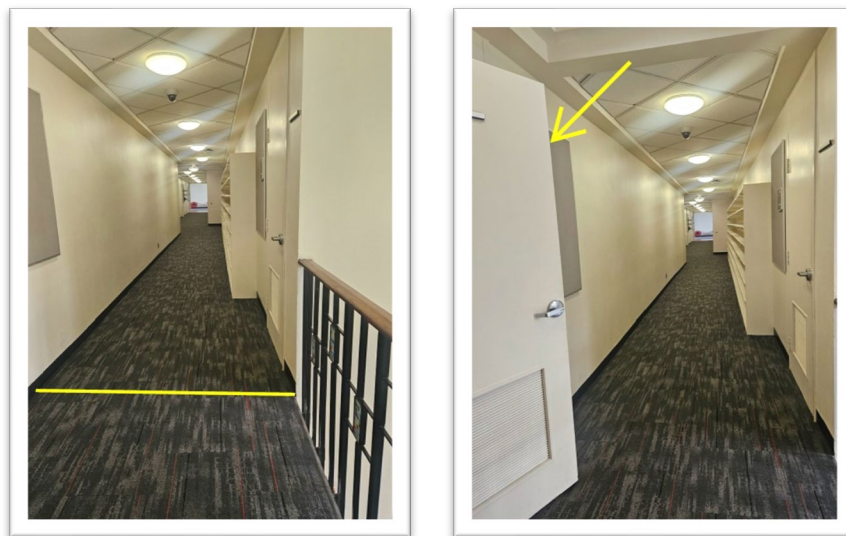
Figure 6: Images of Egress Location; Yellow line indicates location of new wall, yellow arrow indicates door to be closed in (Not picture in floor plan).

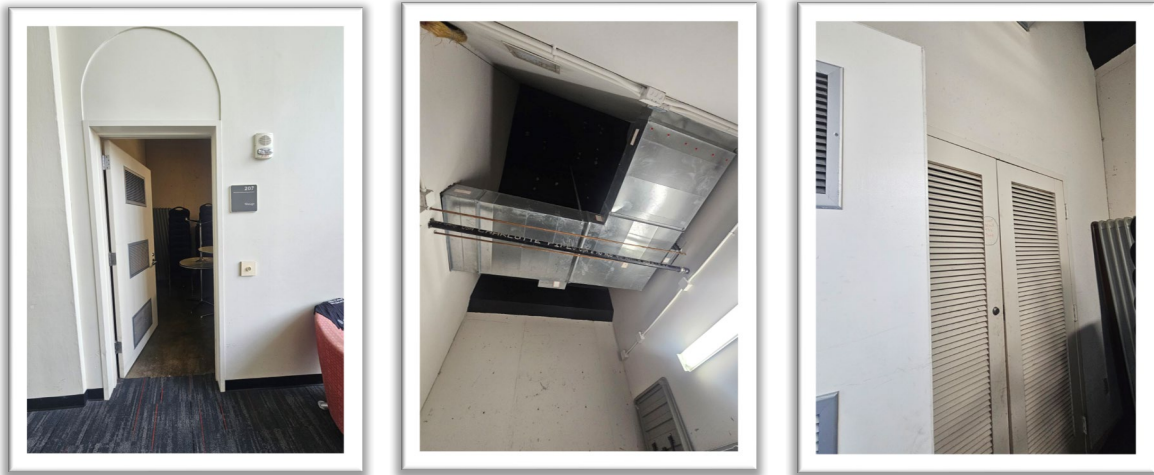
Figure 11: Images and details of New Mop Closet Location

7. Completely Demo Areas 210, 212, 212A, 212B
8. Reconfigure Areas 210, 212, 212A, 212B to include restroom area and multiple private WUDU stations (exact number to be determined in design)
9. Relocate janitor closet (currently 210) to Room 207. This should include tiling, mop service sink and the associated plumbing, drains, and shelving need for the space to function effectively.
